TRAFFIC Study

Indian Mounds Neighborhood

*City of Bloomington
Hennepin County, Minnesota*

WSB Project No. 2175-00

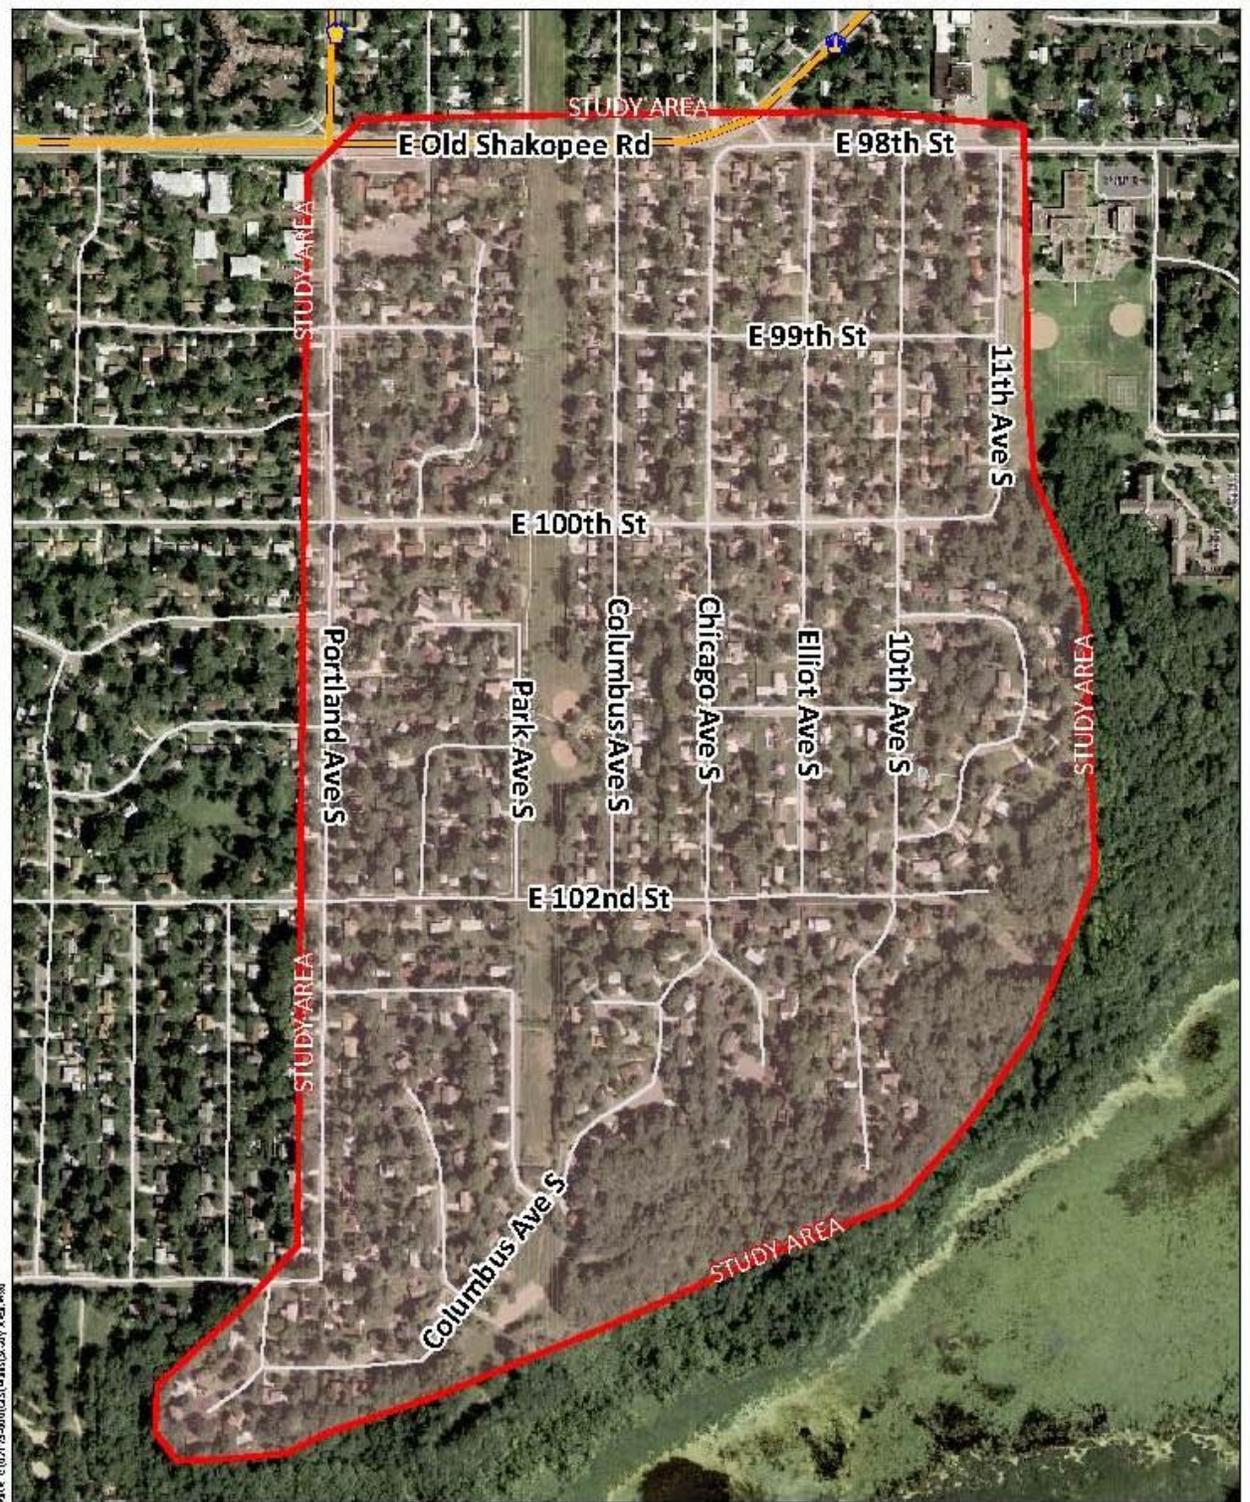
Figure 1. Study Area

The Indian Mounds Neighborhood for the purposes of this study was bounded by the area between Portland Avenue S and 11th Avenue S and between E Old Shakopee Road/ E 98th Street and the Minnesota River bluffs. The Study Area is shown in **Figure 1**.

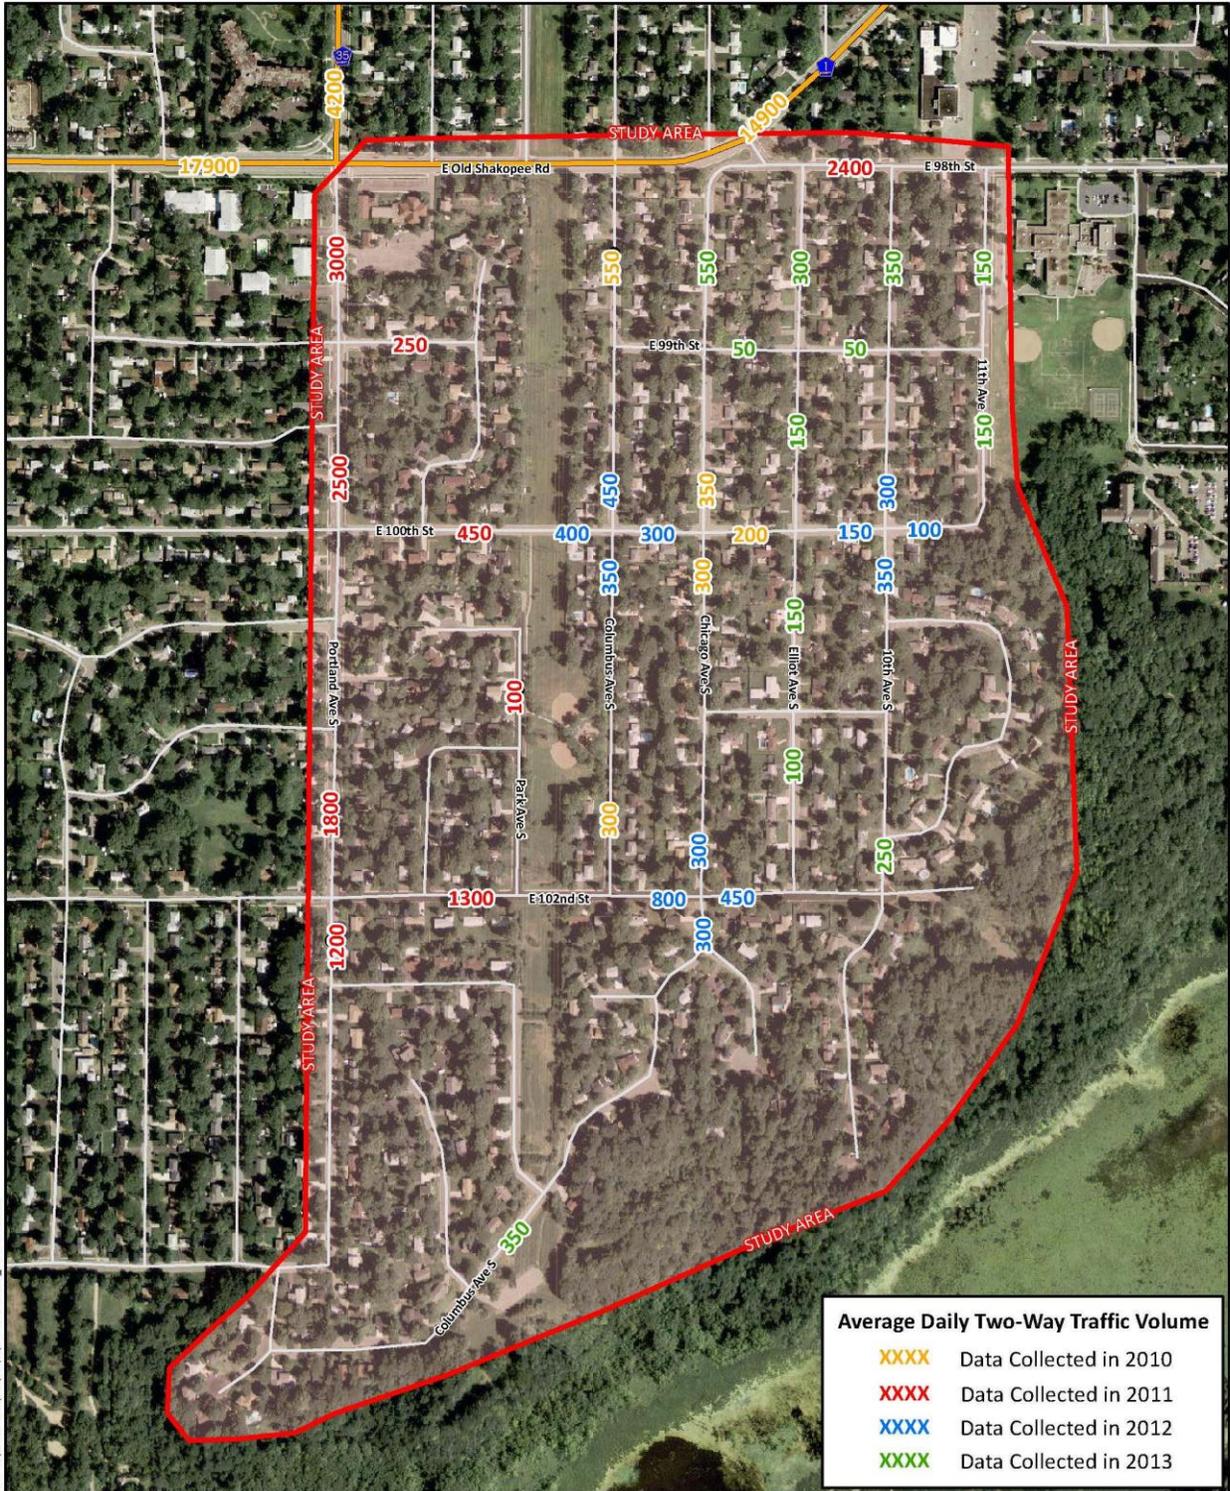
Figure 2. Daily Traffic Volumes

Daily traffic volumes were collected at several locations within the neighborhood between 2010 and 2012. To supplement this data, based on input at the Neighborhood Open House, WSB and Associates collected additional data the week of March 18, 2013. In general, the counts show that the volumes in the neighborhood are at those of typical residential neighborhood streets. Typical residential streets will have traffic volumes up to 1200 vehicles per day (vpd). **Figure 2** shows the Daily Traffic Volumes in the Indian Mounds Neighborhood.

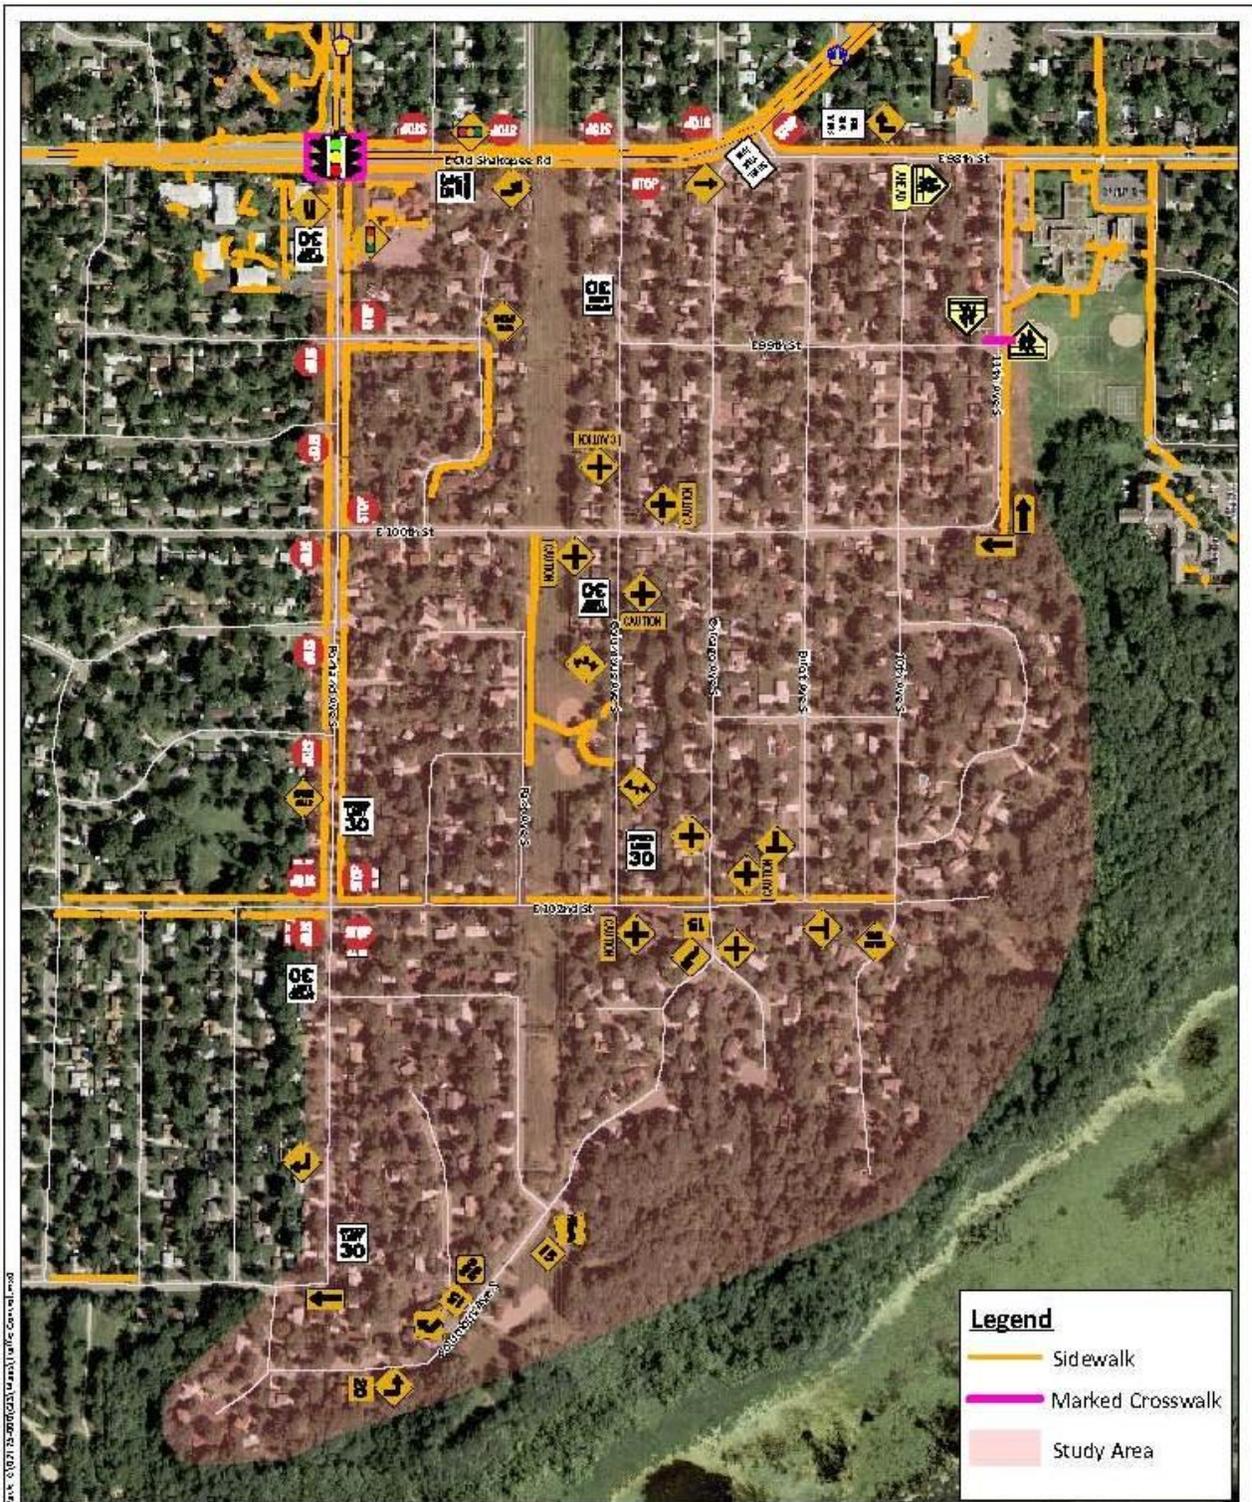
Figure 5. Existing Traffic Control

The existing traffic control was documented within the study area. This included location of: warning signs, stop signs, speed limit signs, pedestrian crosswalks and sidewalks.

Figure 5 shows the existing traffic control devices in the Indian Mounds Neighborhood.

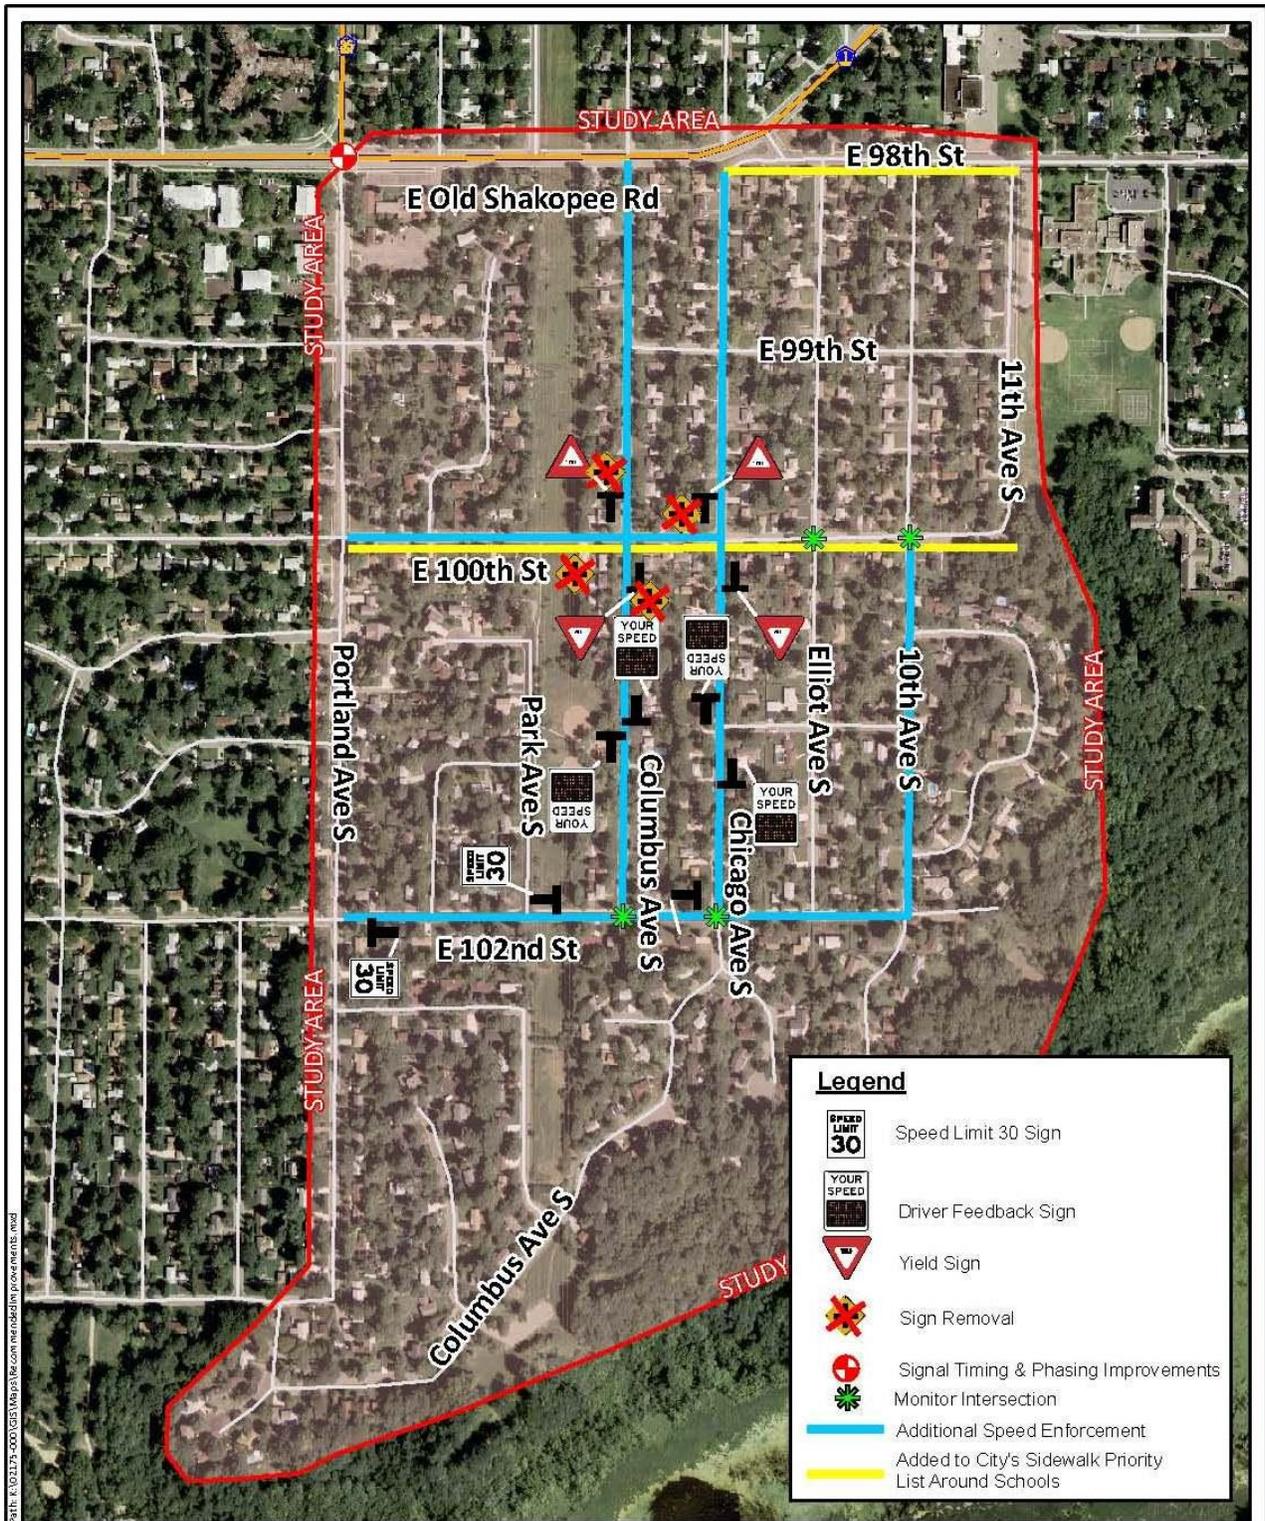
Figure 6
Recommended Improvements

Based on the issues analysis and the analysis conclusions, the following low impact, low cost improvements are recommended in the Indian Mounds Neighborhood Study Area. *Figure 6* shows the location for the proposed improvements.

1. Install Yield signs on both approaches to E 100th Street at Columbus Avenue S.
2. Install Yield signs on both approaches to E 100th Street at Chicago Avenue S.
3. Monitor the following intersections to insure that crashes do not increase as a result of the improvements:
 - a. Elliot Avenue S at E 100th Street
 - b. 10th Avenue S at E 100th Street
 - c. Columbus Avenue S at E 102nd Street
 - d. Chicago Avenue S at E 102nd Street

1. Request additional police enforcement on the following roadway segments:
 - a. Columbus Avenue S, north of E 100th Street
 - b. 10th Avenue S, south of E 100th Street
 - c. E 102nd Street, 10th Avenue S to Portland Avenue S
 - d. E 100th Street, west of Columbus Avenue S
2. Install new 30 mph Speed limit signs at the following locations:
 - a. E 102nd Street eastbound after Portland Avenue S
 - b. E 102nd Street westbound west of Columbus Avenue S
3. Install new Driver feed-back signs in both directions at the following locations:
 - a. Columbus Avenue S, south of E 100th Street
 - b. Chicago Avenue S, south of E 100th Street

1. As a result of the installation of the recommended signs and other devices, four in place signs will need to be removed. They include:
 - a. The advance “Intersection Ahead” signs on each approach of Columbus Avenue S to E 100th Street.
 - b. The advance “Intersection Ahead” signs on each approach of E 100th Street to Columbus Avenue S.
